07/27 14324 P-142
NASA Contractor Report 172358

ACEE COMPOSITE STRUCTURES TECHNOLOGY

Papers by Boeing Commercial Airplane Company

August 1984

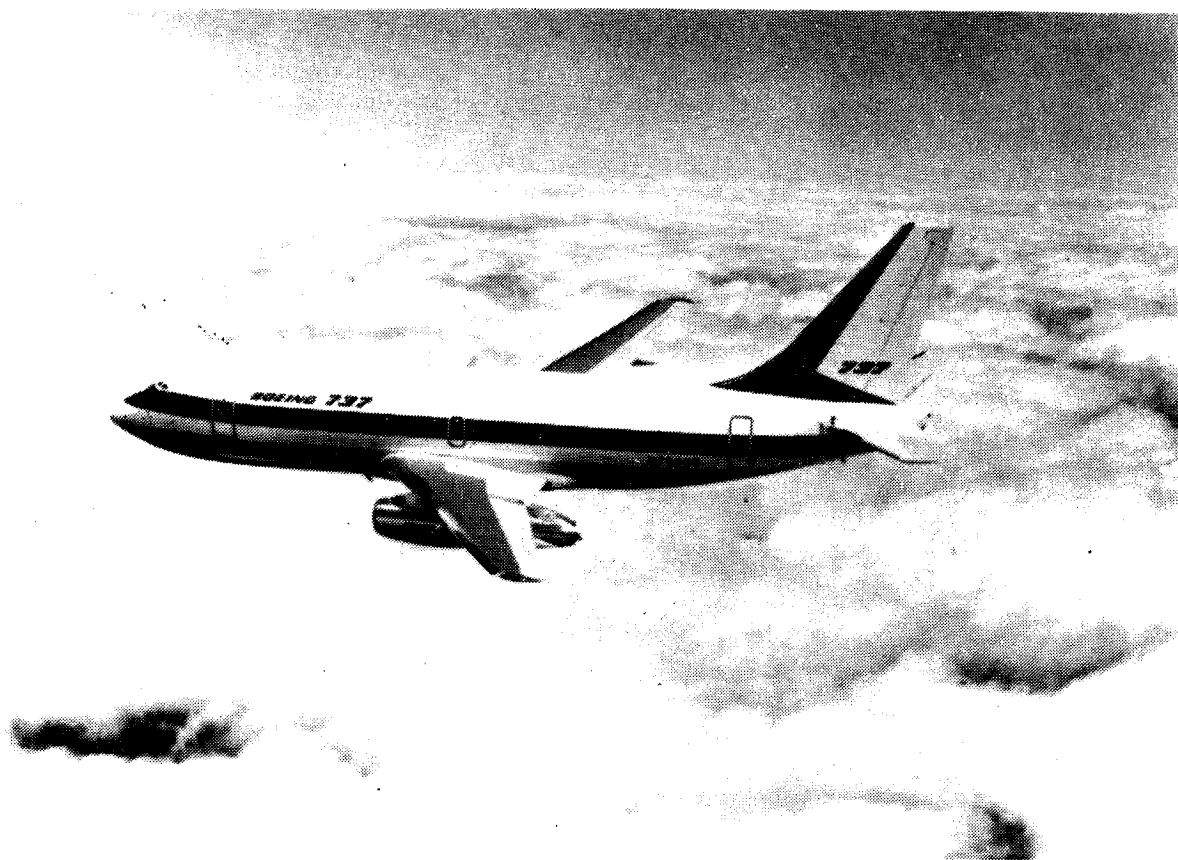
The 737 horizontal stabilizer program has reached a major milestone with the introduction of the stabilizers into commercial service.

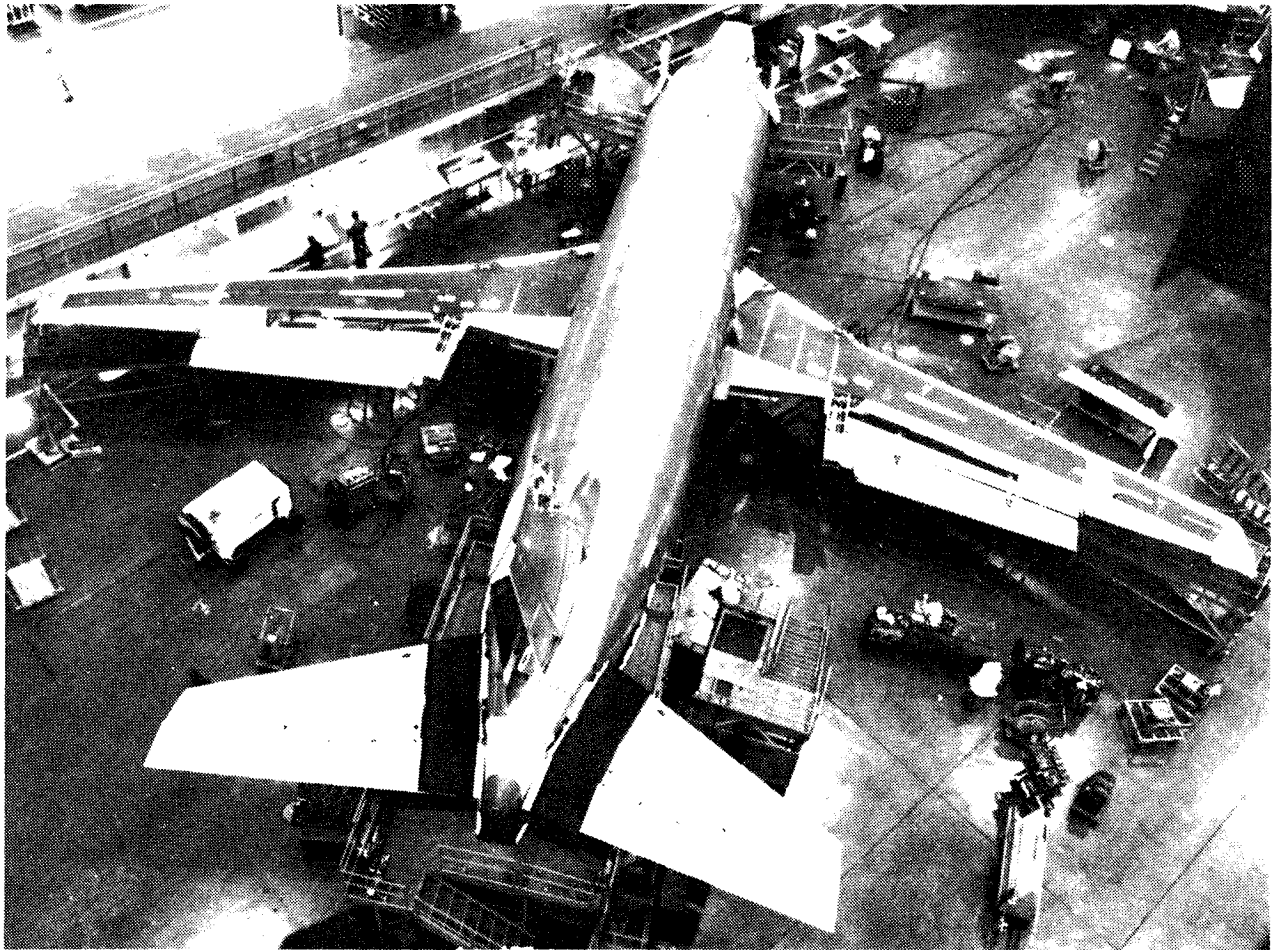
737 Graphite-Epoxy Stabilizer First Installation

The first installation of the 737 graphite-epoxy composite stabilizer is shown.
